## INFORMATION SHEET

### OPENING EXISTING HOLES – “CORING”

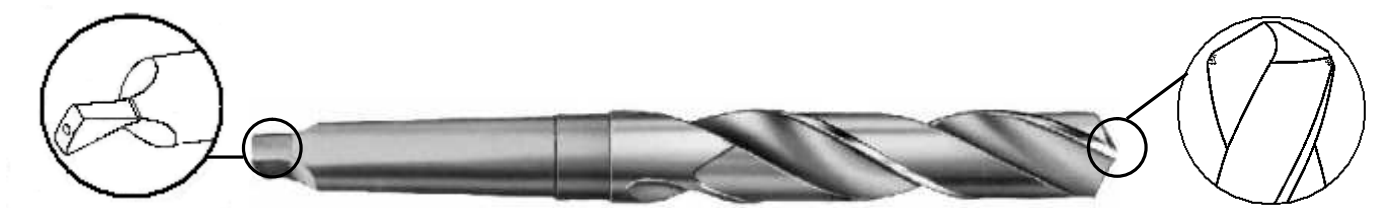
The single most common complaint we receive on taper shank twist drills is the loss of the driving tang or chipping of the outer corners of the drill, sometimes combined. This is caused by trying to open up an existing hole with a two-flute drill. Drill tangs are for ejection purposes only, the drive required is transmitted through the fit of the Morse taper.

**Opening out an existing hole should be performed using a core drill.**

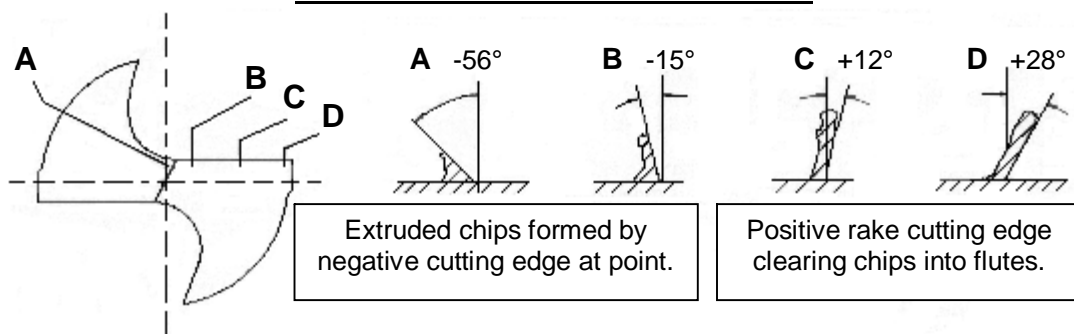
#### ILLUSTRATION OF RAKE ANGLES

A two-flute twist drill starts to cut with the blunt chisel edge, which creates a hole by extrusion, rather than cutting and requires to be forced into the material. After this initial stage the lips of the drill start to cut with a very low rake angle of only  $2^\circ - 3^\circ$  and as the lips come into contact out to the full diameter the rake increases to  $30^\circ$  approximately at the outside edge.

If the user starts to cut an existing hole, it can be seen that the starting rake angle increases further out towards the cutting edge corners, which means that the larger the hole, the greater the self-feed rate of the drill into the workpiece. All “PRESTO” two-flute drills can drill from solid, pilot holes may ease the pressure required when drilling by hand. The pilot hole should not be greater than Point **B** or  $1\frac{1}{2}$  times the chisel edge diameter.
